# NATIONAL TRANSPORTATION SAFETY BOARD

## AIRCRAFT ACCIDENT REPORT

IN-FLIGHT ICING ENCOUNTER AND  
UNCONTROLLED COLLISION WITH TERRAIN  
COMAIR FLIGHT 3272  
EMBRAER EMB-120RT, N265CA  
MONROE, MICHIGAN  
JANUARY 9, 1997

**Abstract:** This report explains the accident involving an EMB-120RT, operated by COMAIR Airlines, Inc., as flight 3272, that crashed during a rapid descent after an uncommanded roll excursion near Monroe, Michigan, on January 9, 1997. Safety issues in the report focused on procedures for the use of ice protection systems, airspeed and flap configuration information, stall warning/protection system capabilities, operation of the autopilot in icing conditions, aircraft icing certification requirements, and icing-related research. Safety recommendations concerning these issues were addressed to the Federal Aviation Administration and the National Aeronautics and Space Administration.

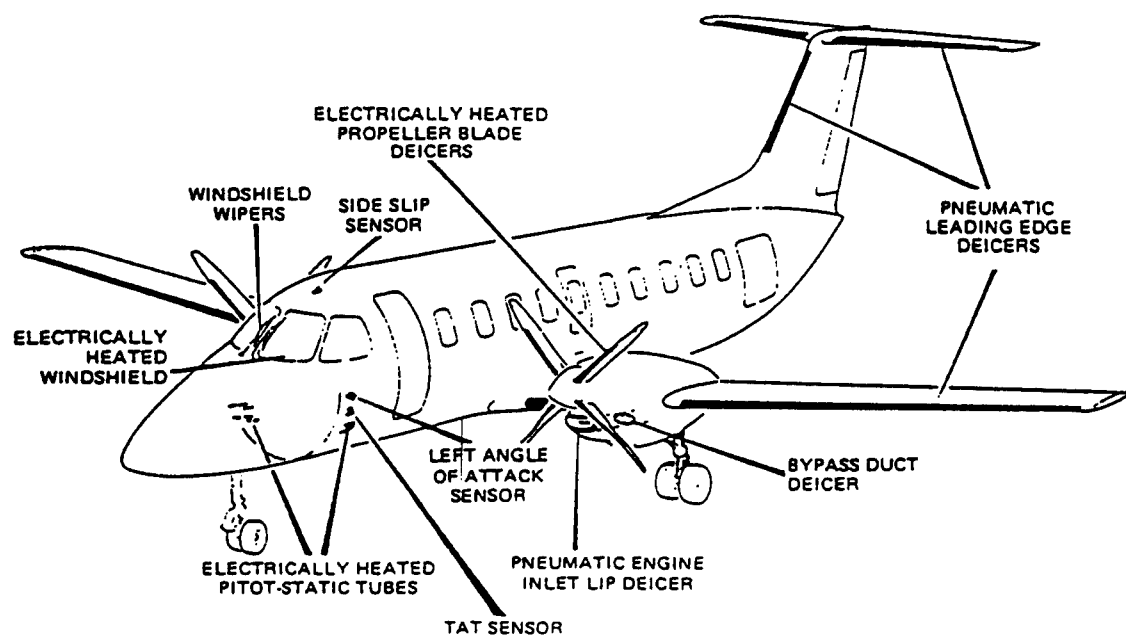
Figure 6.--Ice-protected components of the airplane.

The wing deice boots are divided into three segments (outboard, middle, and inboard), the horizontal stabilizer boots are divided into two segments (inboard and outboard), and the vertical stabilizer boots are a single segment. The tubes in each deicing boot segment are oriented spanwise along the leading edges. The leading edge deicing system is controlled by two toggle switches located on the ice/rain protection panel: the timer select switch and the cycle switch. The cycle switch has two positions: heavy and light. During a heavy cycle, each deicer is inflated for 6 seconds and deflated for 54 seconds; during a light cycle, each deicer is inflated for 6 seconds and deflated for 174 seconds. When activated, the inflation sequence of the deice boots is performed symmetrically, beginning with the outboard wing segments, then middle wing segments, inboard wing segments and inboard horizontal stabilizer segments, and finally outboard stabilizer segments and the vertical stabilizer deicer.

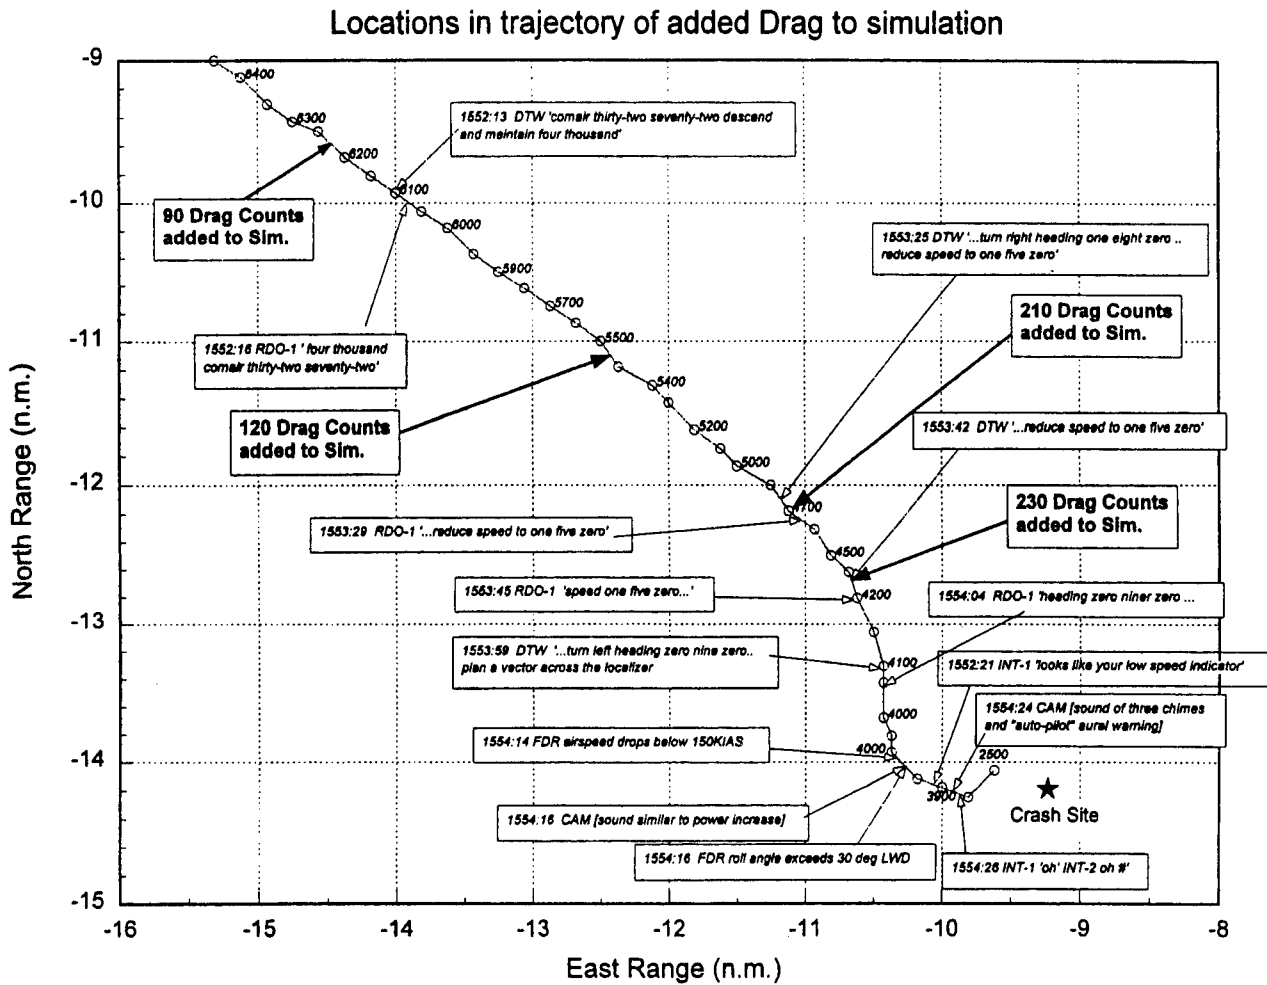
Figure 10.--Ground track of Comair flight 3272.

Figure 10 depicts Comair flight 3272's ground track during its descent, with drag count and CVR information overlaid.

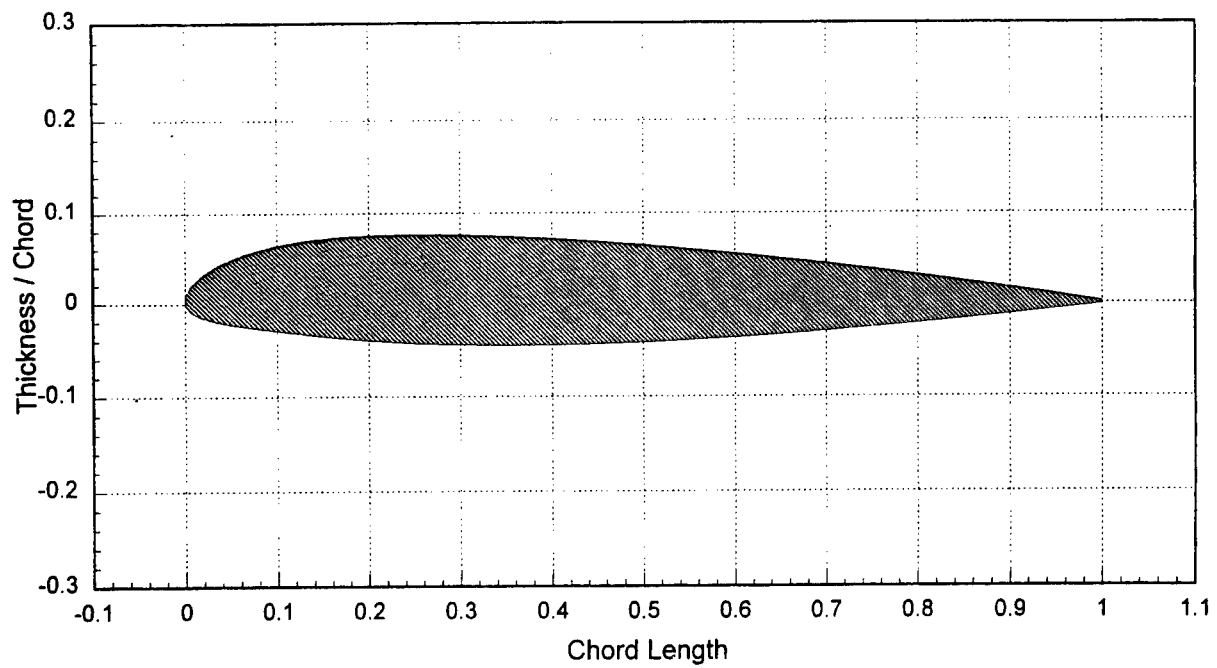
Figure 11.--Cross-section of a NACA 23012/23015 airfoil.

Both icing/wind tunnel tests used airfoil segments representative of the mid-to-outboard section of the EMB-120 wing—a National Advisory Committee for Aeronautics (NACA) 23015 to 23012 airfoil,<sup>94</sup> with leading edge deicing boots similar to the deicing boots on the EMB-120 wing. The UIUC airfoil was about a 1/3 scale model of the NACA 23012 airfoil installed near the wing tip of the EMB-120, with an aileron. The icing tunnel tests conducted at NASA-Lewis used a full-scale airfoil (representative of a section of the EMB-120 wing slightly inboard of the wing tip—a NACA 23014.5 to 23015 airfoil), with functional deicing boots.<sup>95</sup> NASA's airfoil differed from the EMB-120 wing section slightly; most notably, the airfoil had a fixed-position aileron, and the deicing boot extended farther aft on the airfoil's lower surface. (Figure 11 is a cross-section of a NACA 23012/23015 airfoil, with deicing boot limits indicated.)

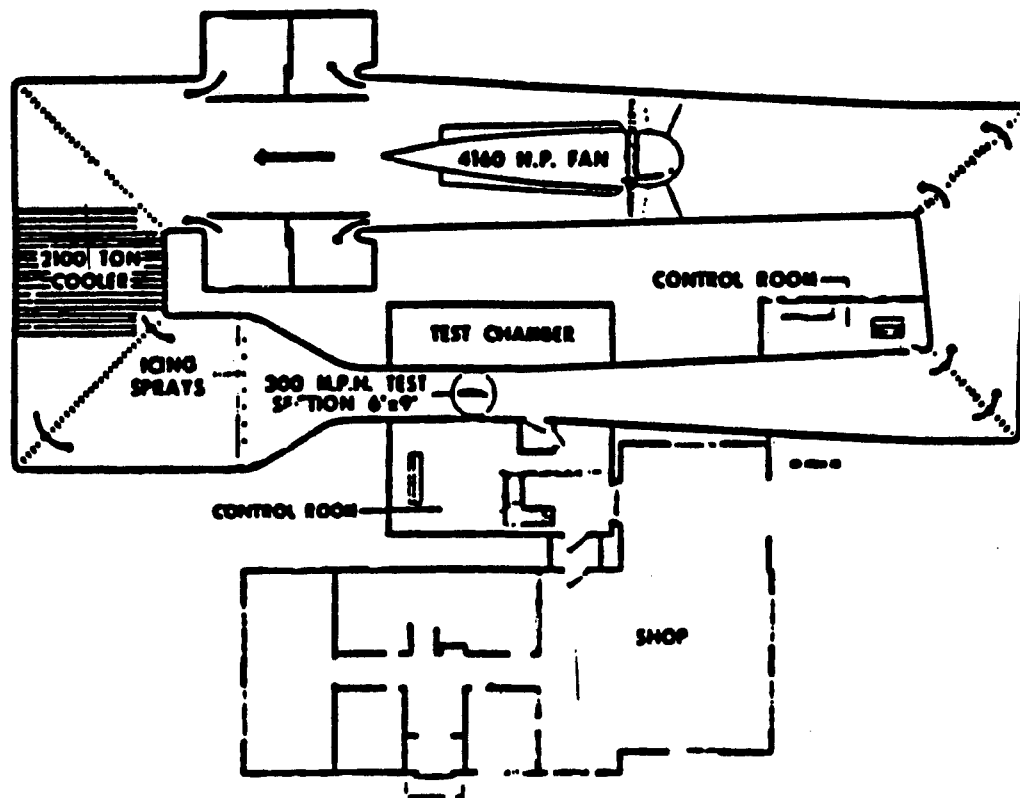
Figure 12.--NASA Lewis Icing Research Tunnel.

The NASA-Lewis IRT is a closed-cycle, refrigerated wind tunnel, with spray equipment installed upstream of the test section (see figure 12). The test section is 6 feet high by 9 feet wide and can accommodate full-scale wing sections. The IRT atmospheric conditions can be varied to provide a range of total air temperatures (TAT), droplet sizes, and LWCs. Also, the airfoil mounting system can be adjusted to vary the airfoil's AOA. The IRT test section is observable through windows from adjoining rooms, and the test facility has video and photographic documentation capability.

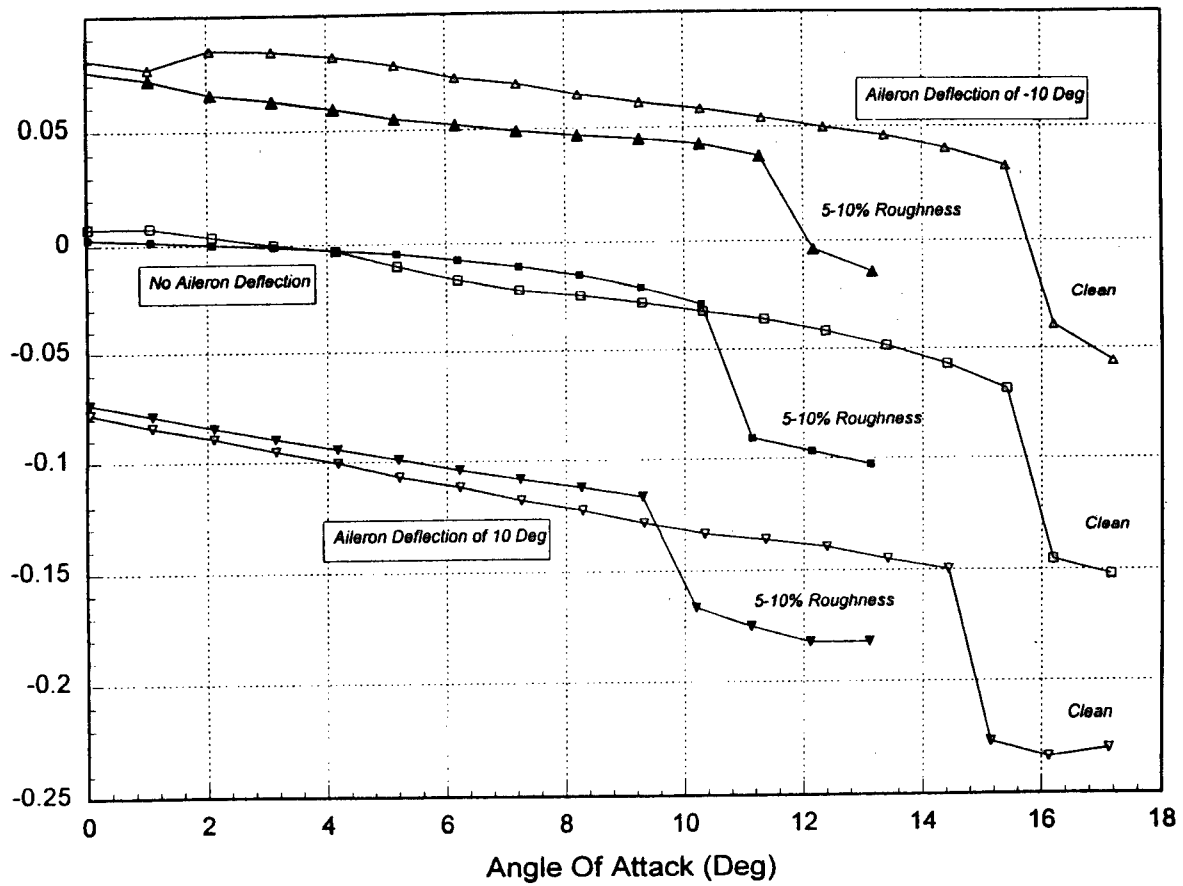
**FAA/Univ of Illinois Wind Tunnel Data  
NACA 23012 Airfoil with Aileron Deflection  
Aileron Hinge Moment Coefficient**
